Torsional Failure Characteristics of a NiTi file based on a Case Report

Jorge N. R. Martins*; Joseph DiBernardo**

(Martins JNR, DiBernardo J. Torsional Failure Characteristics of a NiTi file based on a Case Report. Rev Port Estomatol Med Dent Cir Maxilofac 2010;51:85-89)

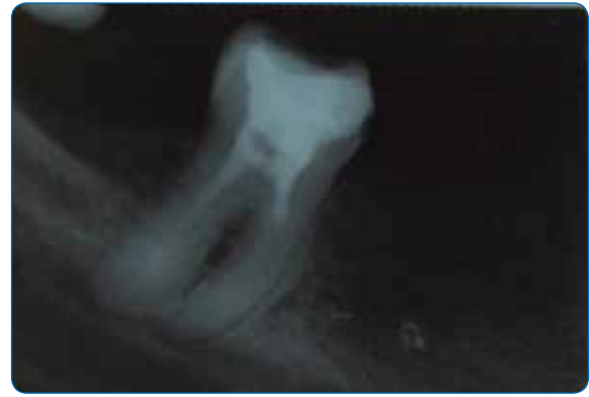
Figure 1 - A diagnostic radiograph. The Prosthodontic clinic requested an improvement of the root canal treatment for a better prognosis.

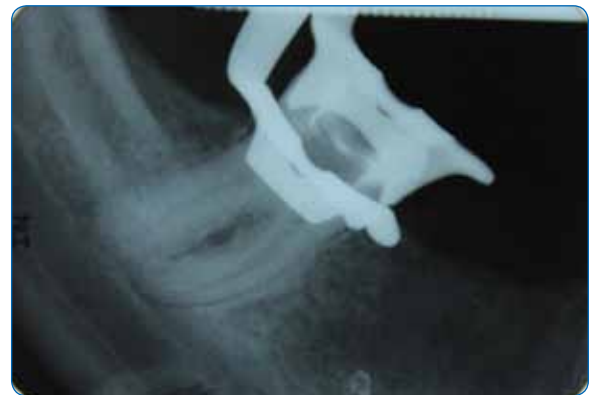
Figure 2 - Radiographic image of a separated ProTaper S1 file on the mesial buccal canal.

Coronal enlargement was first performed with a ProTaper SX file (Tulsa Dental, Tulsa OK) and then a brand new ProTaper S1 (Tulsa Dental, Tulsa OK) rotary file was used to achieve the working length. The instruments were used with a Tulsa Dental Motor (Tulsa OK) at a medium torque setting and a speed of 300 RPM. An instrument separation occurred during this phase of cleaning and shaping (Figure 2). The by-pass option was attempted and was successful. The treatment was concluded in three appointments, with the use of calcium hydroxide as intracanal medication between the appointments. The objective requested by the oral rehabilitation team, the improvement of the quality of the original root therapy procedure, was achieved (Figure 3).

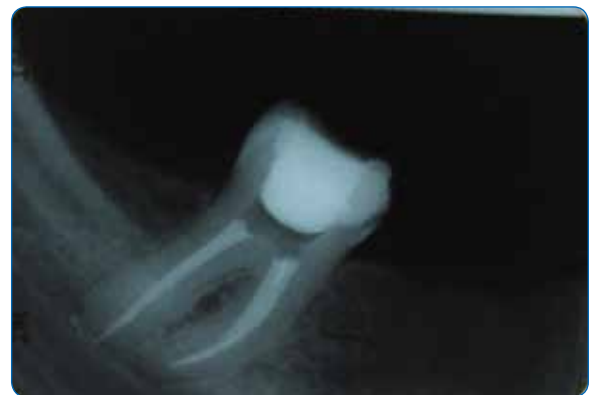
Figure 3 - The final radiograph. The separated file was by-passed and the request of Prosthodontic department was achieved.

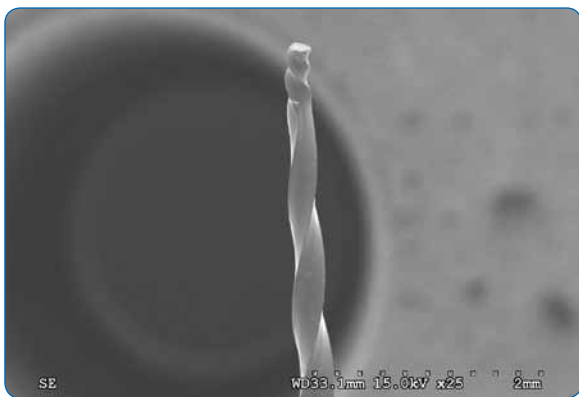
Figure 4 - SEM image of the separated file tip. An 180° unwinding can be seen near to the point of fracture.

twisted 180° in the opposite direction proximal to the point of fracture (Figures 4 and 5). At the base of this unwinding can be seen a severe deformation of the metal alloy (Figure 6). A higher magnification view is able to show several microfractures on the alloy around the severe deformation (Figure 7).

A closer look at the files that suffer this kind of failure may show an unwinding of the cutting edge spirals usually the final result of the plastic deformation previous to the fracture moment^[9] (similar to Fig. 4). On the SEM cross sectional view, the torsional failure usually presents a smooth surface and a central dimpling area with microvoids^[14] (similar to Fig. 8) and may or not be present also dimpling areas on the cutting edges. The central dimpling area may be the result of the rotation of the last area to disassemble at the moment of the separation and the dimpling areas on the file cutting edges may be compatible with a higher stress applied on those areas during the dentin wall cutting process.

The SEM images collected on this separated file show characteristics of torsional failure. The twisted image present near the point of fracture is compatible with a binding situation, the file's tip may have engaged the dentine and blocked while the rest of the file kept rotating and provoked the unwinding until the time of separation. This may have been due to the small patency size of the canal prior to the rotary instrumentation. Separation of this kind can be avoided by enlarging the canal with the appropriate hand filing technique to prevent binding of the file.

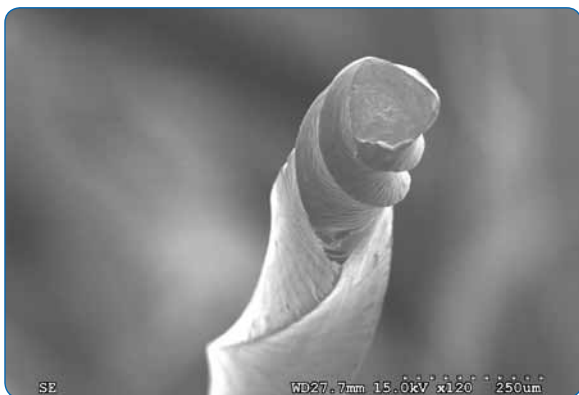
Figure 5 - SEM image of the separated file tip. Another vision of the unwinding area near to the point of fracture.
